**General  
Services  
Administration  
Caribbean Property  
Management Center**

**Parking Garage  
PR0024ZZ**

**Post-Earthquake Assessment**

**STRUCTURAL REPORT**  
**VISUAL INSPECTION OF THE**  
**PARKING GARAGE (PR0024ZZ)**

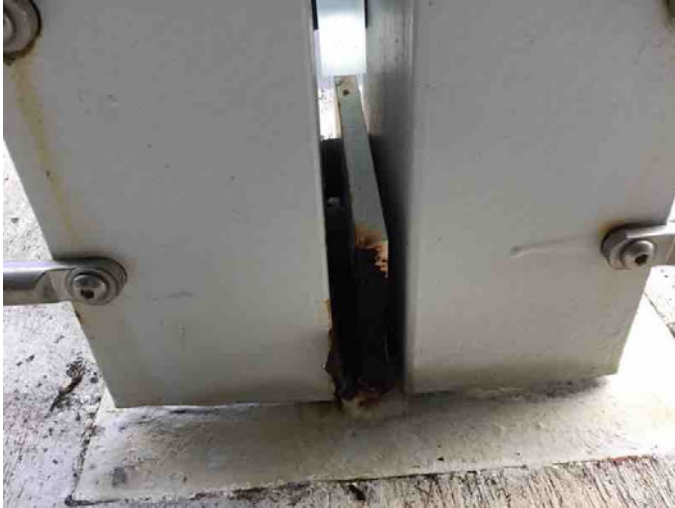
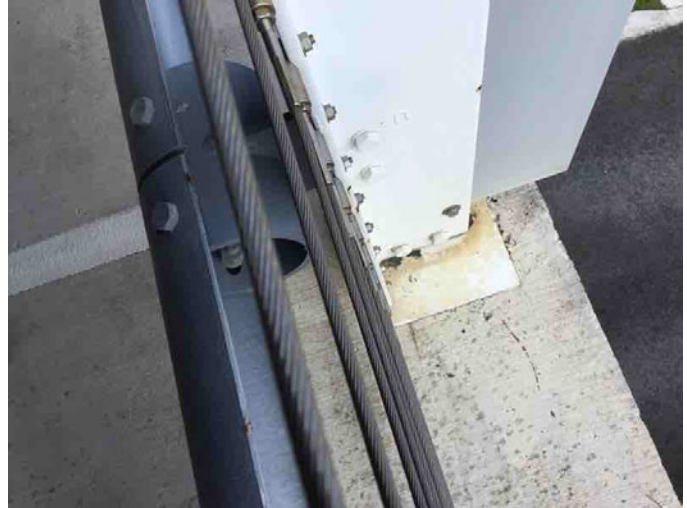
16 + 1/13/20

Corros on process at some connect ons of the guardra s. Typ ca at var ous ocat ons.

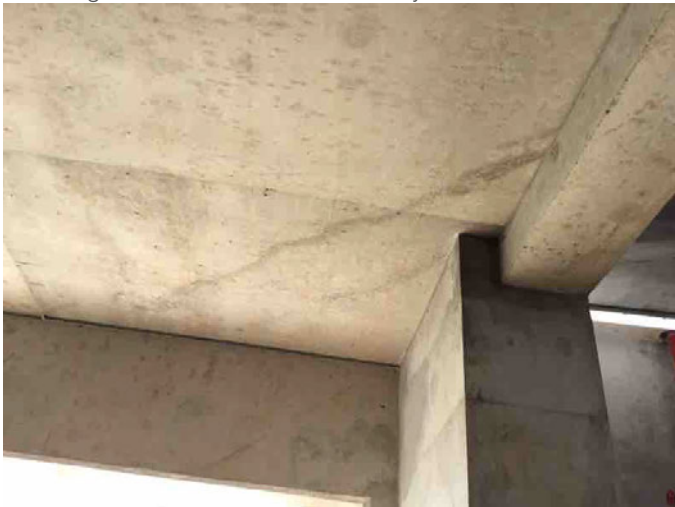
17 + 1/13/20

Crack ng of 2nd floor slab. Defect may be re ated w th m nor sett ements.

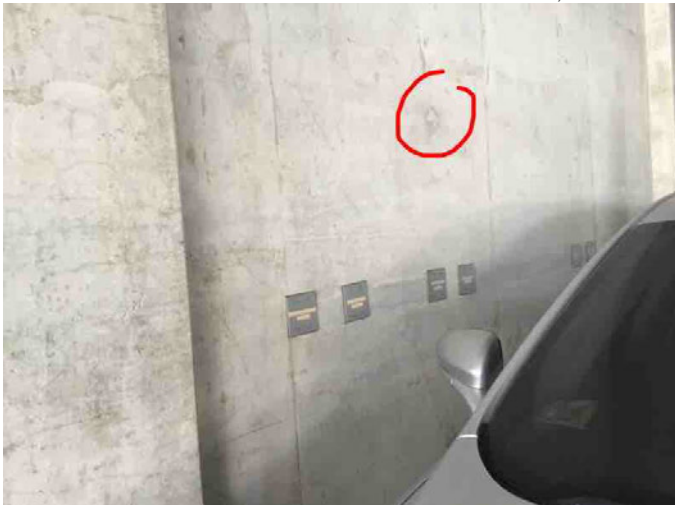
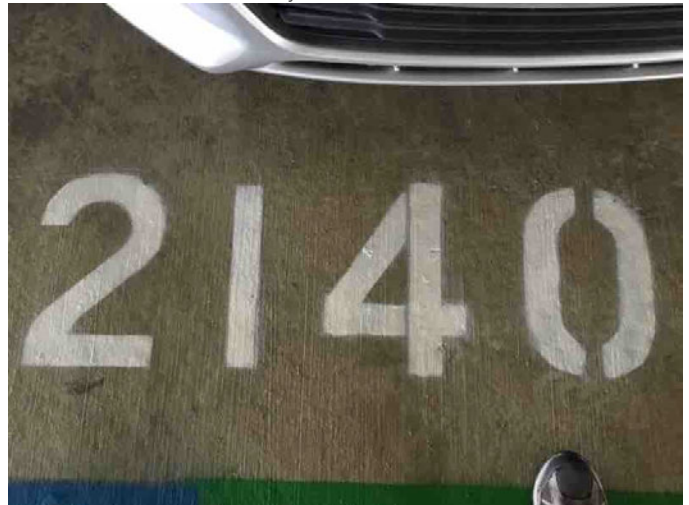
28 + 1/13/20

Dagona har ne cracks on structura wa . Previous defect. (Some cracks appear to be nvest gated due to presence of concrete cores. Od marks on some of them for dent ficat on). Not related w th recent se sm c act v ty.

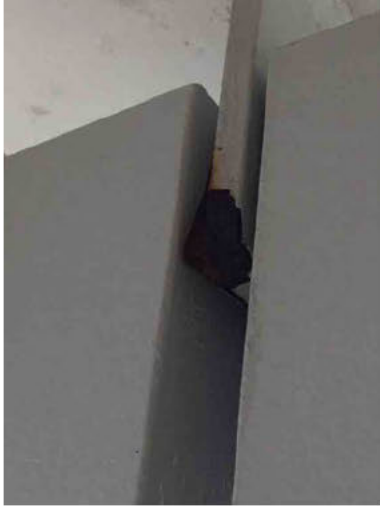
31 + 1/13/20

Corros on of steel plates. Maintenance required. Typ ca at various ocations.

Attention shall be given to fix corrosion problems in steel components. Pre-existing cracks and spalling would be fixed using special cementitious materials.

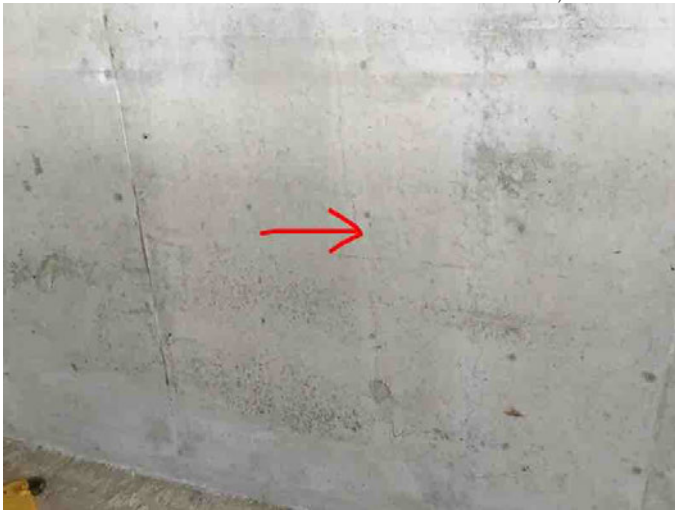
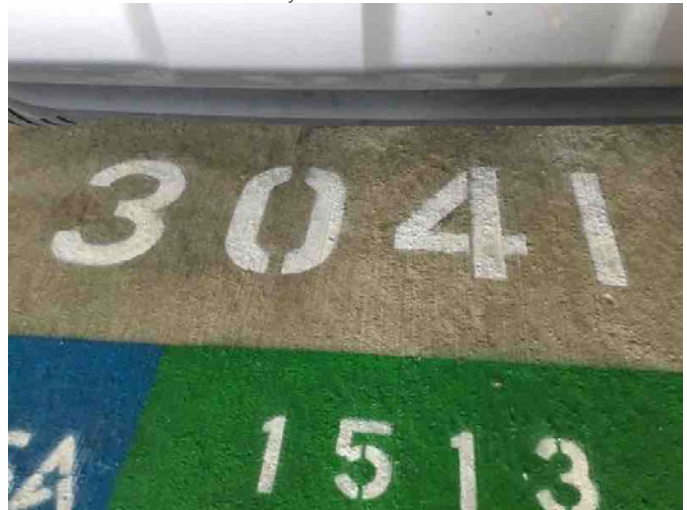
36 + 1/13/20

Dagona har ne cracks on structura wa . Prev ous defect. (Some cracks appear to be nvest gated due to presence of concrete cores. O d marks on some of them for dent ficat on). Not re ated w th recent se sm c act v ty.

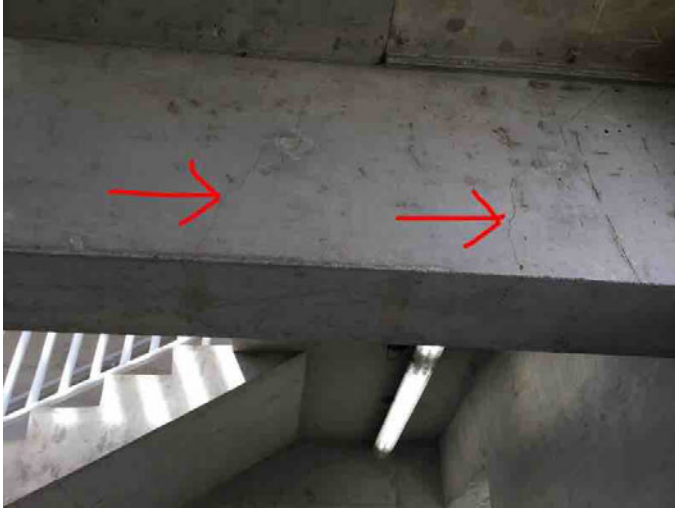
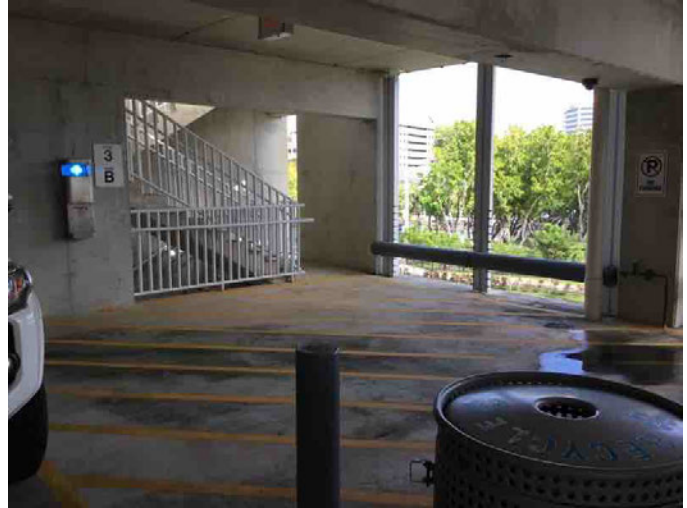
40 + 1/13/20

Har r crack at sta r #2 (o d crack that wou d be assoc ated w th m nor sett ements).

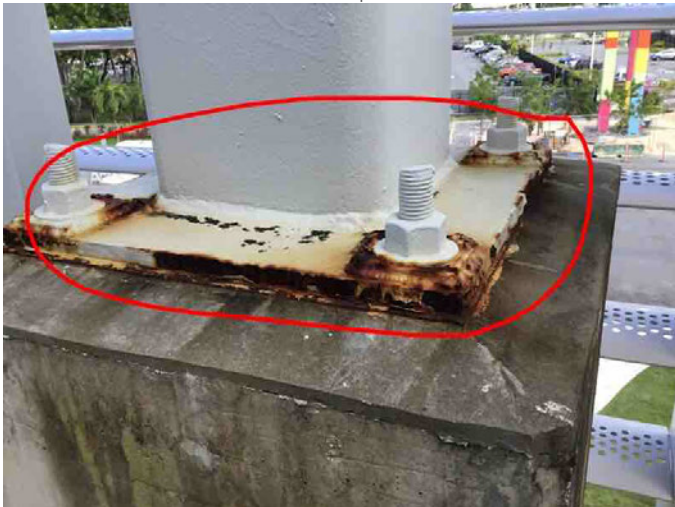
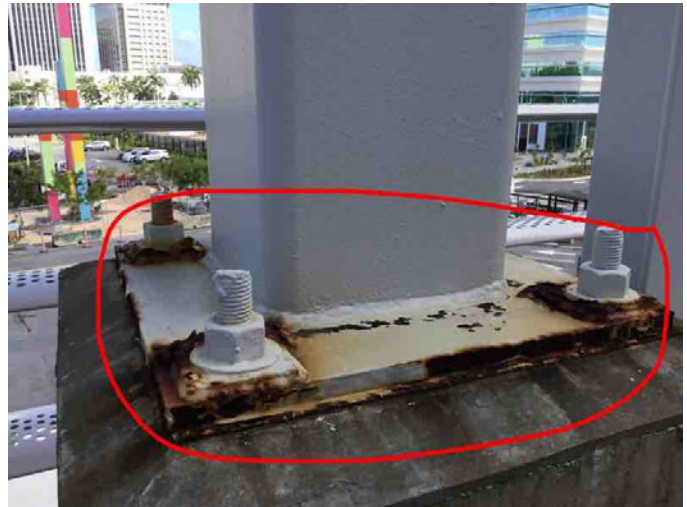
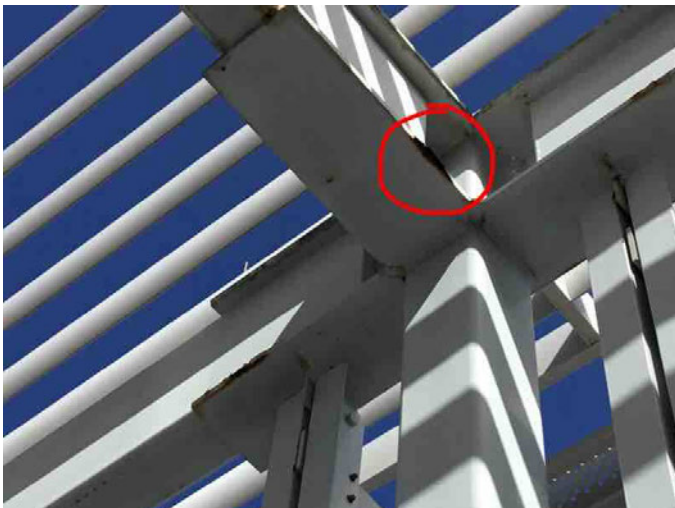
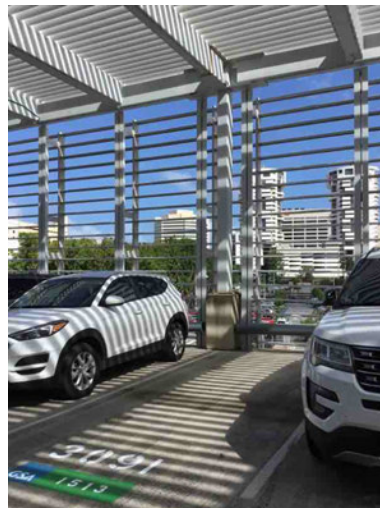
41 + 1/13/20

Moderate corros on. Th s tem requ res attent on.

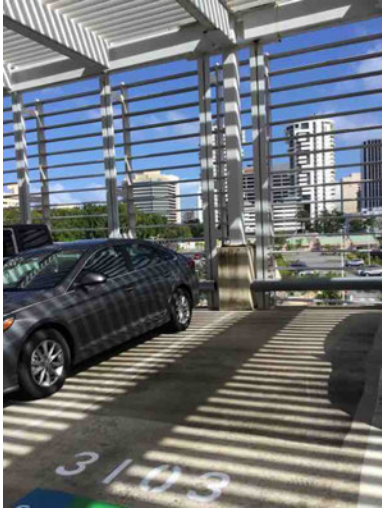
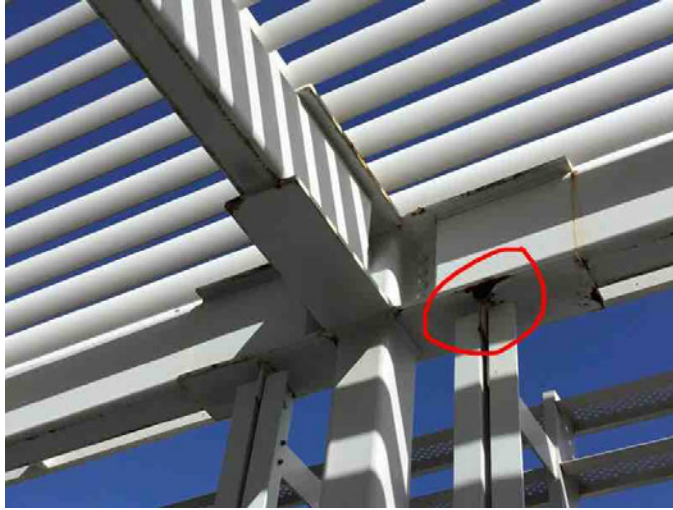
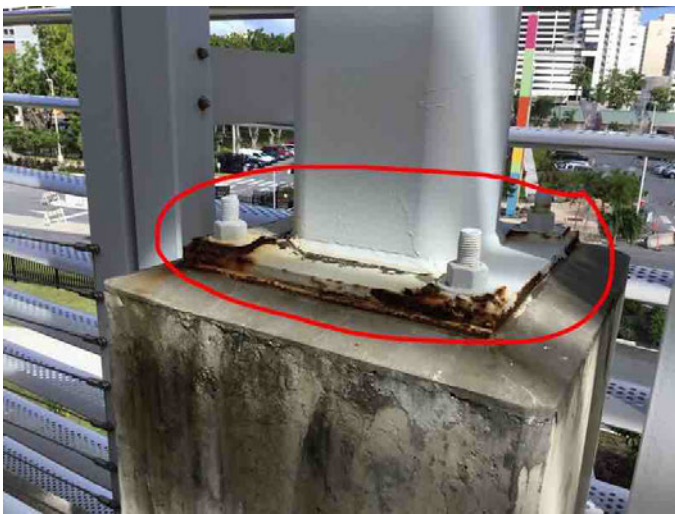
42 + 1/13/20

Corrosion of exposed steel plates.

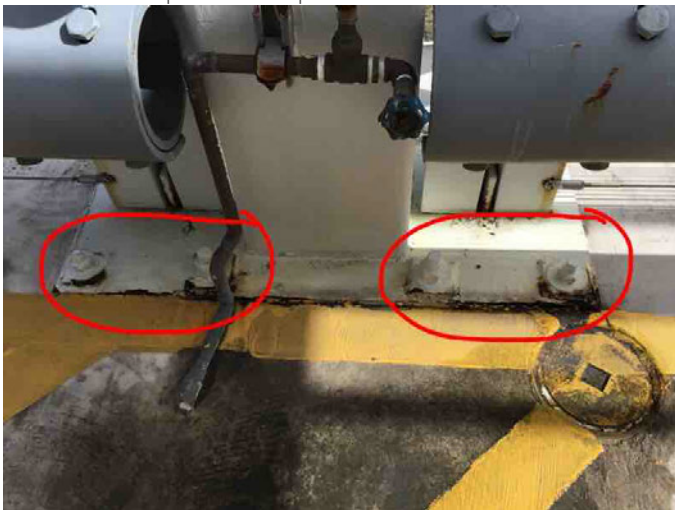
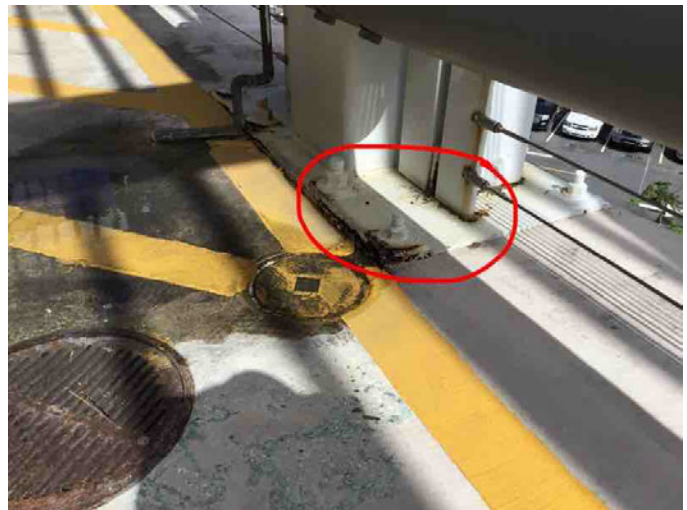
43 + 1/13/20

Corrosion of exposed steel plates.

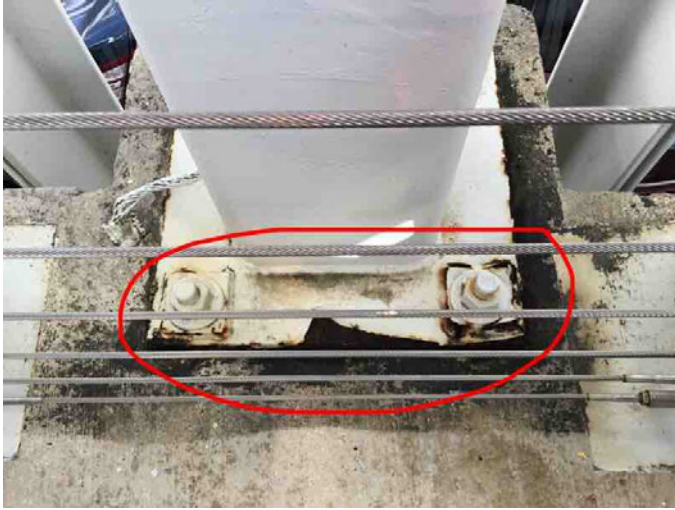
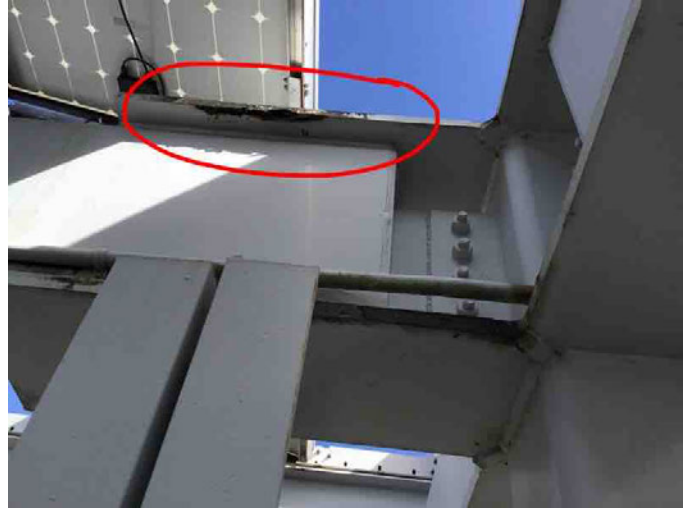
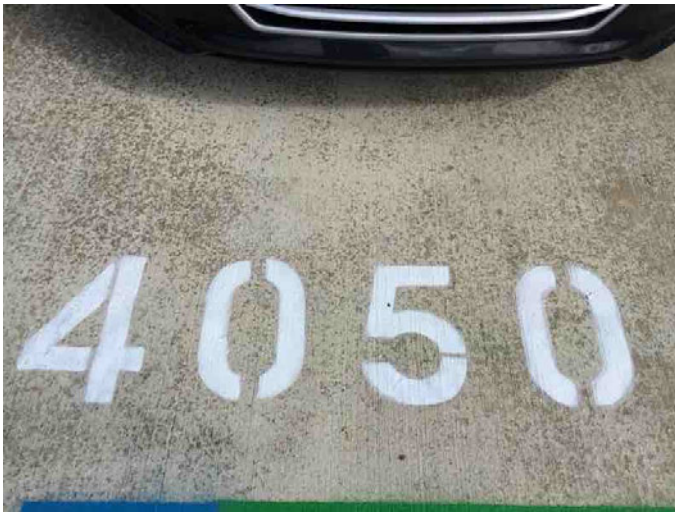
49 + 1/13/20

Corros on of exposed stee p aates.
